Simulated transport damage study on fresh tomato (*Lycopersicon esculentum*) fruits

Abstract: A simulated transport study under laboratory conditions was conducted to assess the performances of the current traditional basket which is the sole packaging container for tomato fruit handling and a plastic container which is currently not in use in the system. A developed vibrating table was used to excite vibrations and impact on the packaged fruits in these containers according to the ASTM D4169-08 International Standard, Assurance Level II. The results showed that 40%, 37.50% and 45% of the samples of tomato fruits from the top, middle and bottom of the traditional basket respectively were severely bruised after four hours of excitation. In the case of the plastic container, the corresponding values were 44.18%, 30.23% and 18.60% for the samples taken from the top, middle and bottom of the container, respectively. The average bruise width of the damage samples packaged in the traditional basket was 24.36 mm while the average length was 36.67 mm. In the case of the plastic container, the average bruise width was 15.18 mm and that of the length was 26.97 mm. The ANOVA shows that these

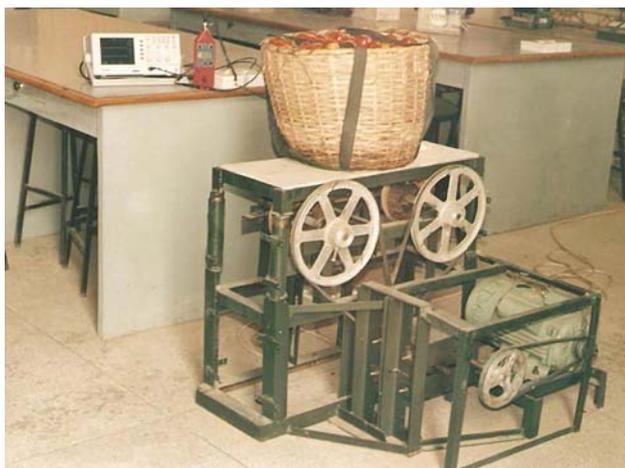
Figure 1 Set up with fresh tomato packaged in the traditional basket (PM1)

The developed vibration table was used to simulate a typical road transportation condition in Nigeria under laboratory conditions. The sensor of the vibration meter (VI-100 from Quest Technologies) was mounted on the platform of the table. The AC output of the meter was connected to a Digital Storage Oscilloscope (GDS- 1000 Series, GDS 1062, 60 MHz from GWINSTEK) where the output either in terms of displacement, velocity or acceleration (in g's rms) was displayed. The output signal were recorded on a memory card and transferred to PC. The experimental set up is as shown in Figures 1 and 2.

In this experiment, two packaging containers namely, the palm basket (traditional) and a plastic basket were used to study their effects on the mechanical damage of the fruits. The containers were packed with 20 kg of the fresh tomato fruits and fixed on the platform of the vibrating table. The ASTM D4169-08 International Standard by Michel Magendans (Kipp, 2000) was adopted for the test. This standard described the test procedure for transport simulation test using a single-packaging or a combination of pallet-packaging and where the truck simulation acceleration and vibration spectrum are specified depending on the assurance levels. Three assurance levels are specified in the standard and Assurance level II was adopted in this study.

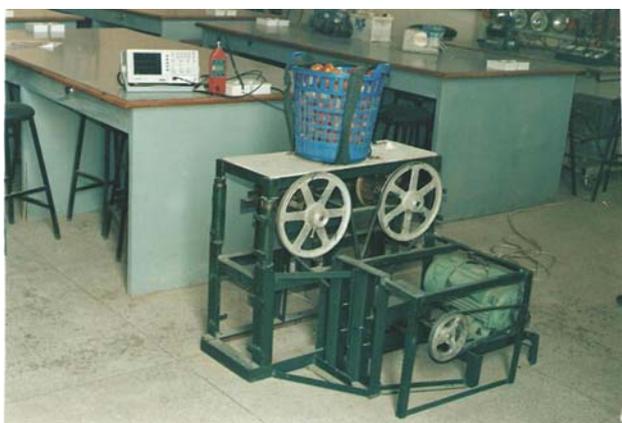
Figure 2 Set up with the fresh tomato fruits packaged in the plastic basket (PM2)

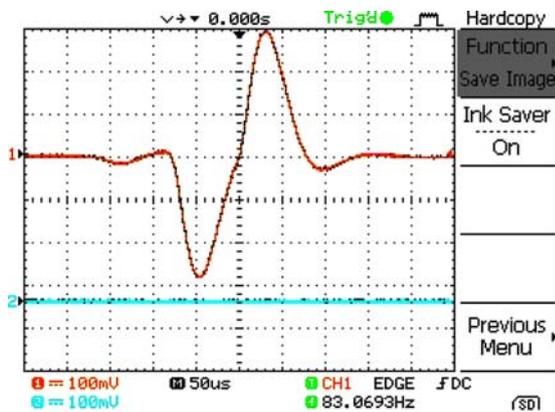
a. Vibration amplitude on the table top displayed by the digital storage oscilloscope during the laboratory simulation

The average root mean square (r.m.s) value of the measured acceleration of the vibrating table during the exercise was 0.25 g on the table platform, 0.22 g and 0.20 g inside the traditional basket and plastic basket respectively. The packaging transmissibility for the two packaging containers was 88% and 80% for traditional

basket and plastic basket respectively. The average r.m.s. value of the measured displacement (i.e. amplitude) read out from the vibration meter is 2.46×10^{-5} m. A sample of the displayed vibration output signal captured during the test is shown in Figure 3.

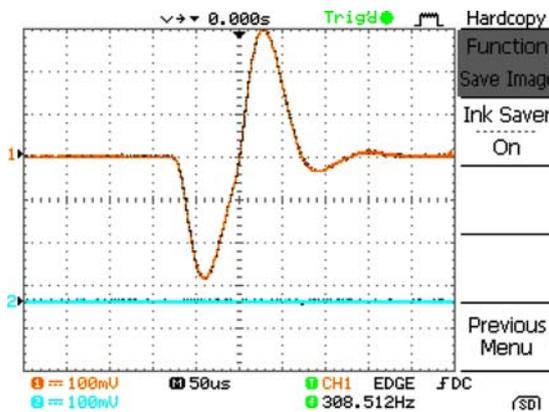
b. Vibration amplitude inside the traditional basket displayed by the digital storage oscilloscope during the laboratory simulation

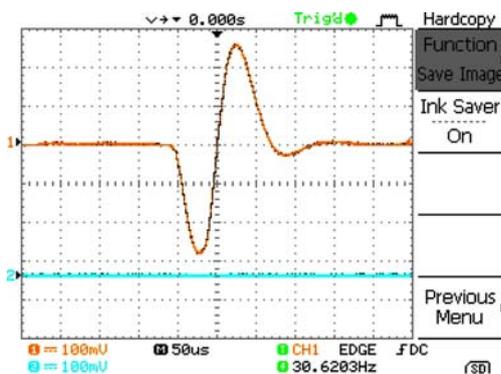
c. Vibration amplitude inside the plastic container displayed by the digital storage oscilloscope during the laboratory simulation

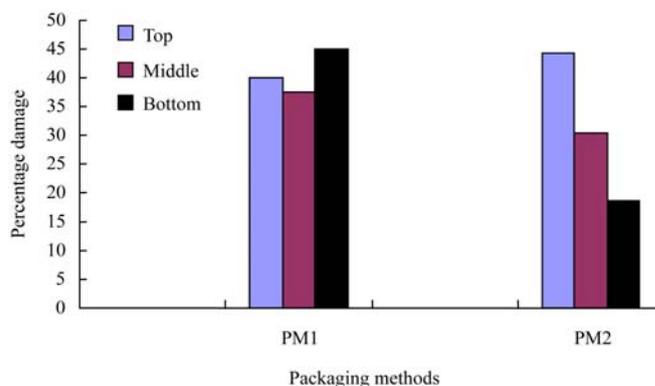
Figure 4 Percentage damage of tomato fruits after four hours of stressing using two packaging containers

The results of the damage assessments carried out on the samples of fruits from various depths of loading inside the two packaging containers (traditional basket PM1 and plastic basket PM2) are shown in Figure 4. The damage consisted of darkened streaks (bruises) on the skin with signs of water soaked underneath the skins.

The results (Figure 4) showed that in the traditional basket (PM1), 40%, 37.50% and 45% of the samples of tomato fruits taken from the top, middle and bottom of the basket respectively were severely bruised after 4 hours excitation which according to the ASTM D4169 truck. Assurance Level II stimulates an average distance of 2,100 km. With regards to the plastic basket (PM2), the corresponding values were 44.18%, 30.23% and 18.60% for the samples taken from the top, middle and bottom of the basket respectively after 4 hours of stressing. It was observed that most of the severely bruised fruits in the traditional basket were those in direct contact with wall and floor of the basket. These are areas where friction between the fruits and surface of the packaging container was more. In the case of the plastic container, it was observed during the exercise that the magnitude of vibration at surface was greater as the fruits were moving freely and impacting on each other and this is responsible for higher percentage of damage at the top or surface of the packaged fruits. These results agree with other studies (Jones et al., 1991; Ran et al., 2007). Unlike the traditional basket, samples of the fruits at the bottom of the plastic container suffered the least bruises. The overall results indicate that samples of the fresh

tomato fruits packaged in the traditional basket suffered more damage (40.83%) than those packaged in the plastic basket (30.98%).

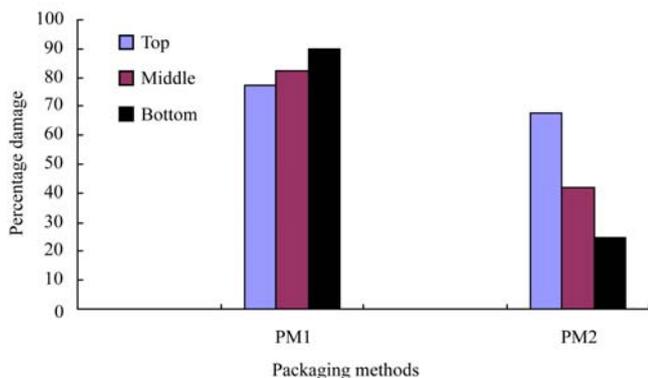
Figure 5 Percentage damage to tomato fruits 24 hours after stressing for four hours using two packaging methods

The fruits were stored for two days in the laboratory at 23°C and 67% relative humidity. The results of the assessments of the extent of damage of fruits are as presented in Figure 5 and Figure 6.

After 24 hours of storage, the percentage of damaged fruits increased to 77.50%, 82.50% and 90% for samples from the top, middle and bottom positions respectively in fruits packaged in the traditional baskets (Figure 5). For the samples in the plastic container, the values were 67.44%, 41.86% and 25.00% for those from top, middle and bottom positions respectively. It was observed that the samples of fruits that showed signs of bruises on the first day of the experiment became rotten or decayed.

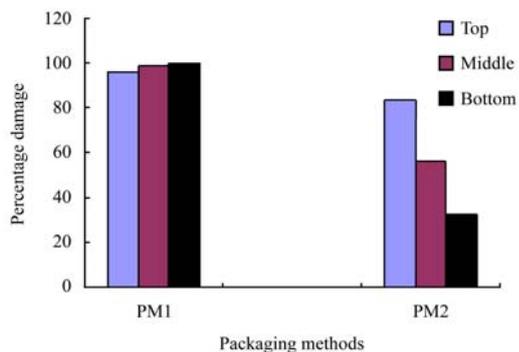
Figure 6 Percentage damage to fresh tomato fruits 48 hours after four hours of stressing using two packaging methods

After 48 hours of storage most of the fruit samples that were packaged in the traditional baskets had become completely decayed. The opening of the bruised areas led to release of moisture from the damaged fruits. This also exposed the fruits to infestation by other spoilage organisms thus accelerating the rate of decay. Those that were not rotten showed signs of shrinkage and this led to decrease in weight as can be seen in Figure 7. The results showed that the samples packaged in the traditional basket suffered greater weight losses than those packaged in the plastic container. The control sample (unvibrated) showed less reduction in weight during this same period of storage. Some of the samples are shown in Figure 8 and Figure 9.

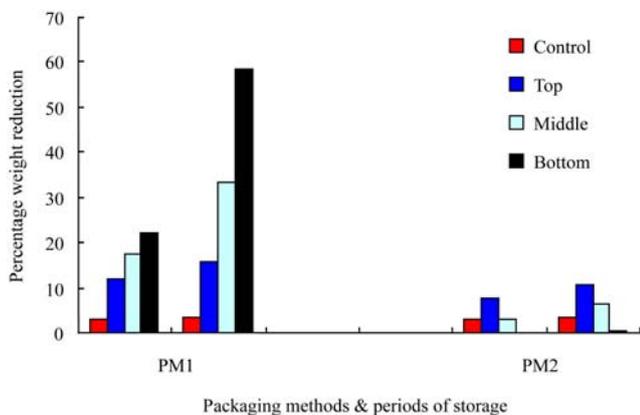
Figure 7 Percentage weight loss in the fresh tomato fruits during the period of storage after vibration

Figure 7 shows the percentage weight loss from the samples of the stressed fruits. Some samples of the

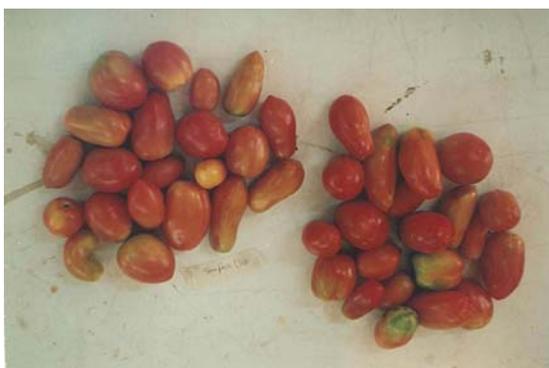
Figure 8 Some samples of the stressed tomato fruits using the traditional basket

damaged tomato fruits are as shown in Figure 8 and Figure 9.

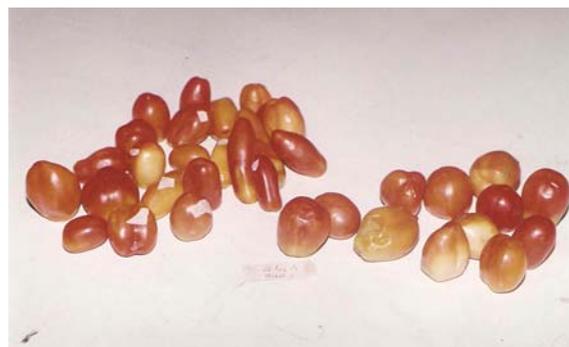
Figure 9 Samples of the stressed tomato fruits packaged in plastic container
