### Impact of Tropical Cyclones on Rural Infrastructures in Bangladesh

Tropical cyclone has a great impact on agricultures and rural infrastructures such as shelter, sanitation, drinking water, electricity supplies and transportation services. It causes huge damages not only to livelihoods but also to engineering structures like rural roads, dams, embankments, farm buildings and dairy houses etc. This paper depicts the results of recent studies on impact of tropical cyclones on rural and agricultural engineering infrastructures in Bangladesh based on the field visits to cyclone sites, collected data and information on damages and death of peoples. Necessary data related to tropical cyclones are obtained from available publications and news paper information reported in the recent years and previously. It is found that, in 2007, Bangladesh again witnessed unprecedented tropical cyclone called as "Sidr" caused enormous disruptions, damages and remarkable number of death of peoples. The country was yet to fully repair many of the damages done to her infrastructure due to devastating flood occurred in the same year just three months ago. It is revealed that the coast of the Bay of Ben

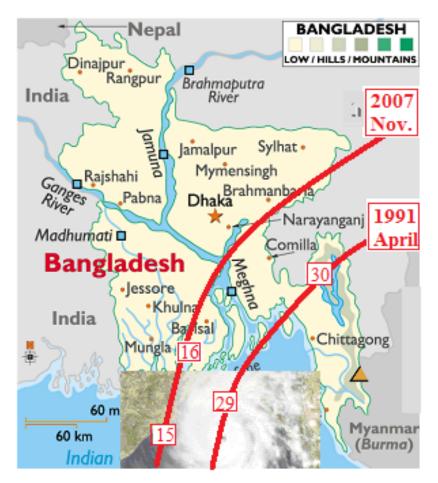
The path of the two recent severe cyclones along with the physical facts of Bangladesh is shown in Fig.2. It should be noted that Bangladesh extends between  $21^{\circ}$  and  $27^{\circ}$  North latitude and  $88^{\circ}$ and 92.5° East longitude. The Bay of Bengal is in the south side of the country. The total area is 144000 sq km and size of population is around 15 million (2007). Per capita income is around US\$550.0, one of the lowest in the world. The coastal land of Bangladesh (710 km long) is of recent origin formed out of the process of sedimentation. Most parts of the area are, therefore, low lying which can be subjected to inundation even under ordinary circumstances of tides. A tidal surge accompanied by a cyclone storm makes the situation alarming which is further exacerbated by the triangular shape of the Bay of Bengal (Fig.2). The wide shallow continental shelf is conducive to amplification of surges causing wide spread flooding. The country has been subjected to frequent natural disasters in many forms, particularly cyclonic storms and tidal surges. From 1970 to 2007, four major cyclone storms and tidal surges have been reported. These indicate that Bangladesh is prone to frequent destructive tropical cyclones associated with tidal surge. The low-lying coastal areas are particularly vulnerable, thus placing these population, infrastructure, agriculture, livestock and economic development in a high-risk situation. During the 1991 cyclone, the cyclonic storm was detected as a low pressure area over the Southeast Bay and adjoining Andaman Sea on 23 April. Finally, the cyclone of hurricane intensity crossed the Chittagong coast a little north of Chittagong at 2 am of 30 April, 1991 that killed some 143000 people in Bangladesh. The aspects of the detection of the cyclone, its monitoring and prediction and weakness of warning and special weather bulletins have been reflected upon. Most of the worst affected areas are either off-shore islands or coastal areas. The less affected areas are mostly located inside and further from the coast. The 2007 cyclone Sidr smashed into the country's southern coastline late on Thursday midnight of November 15 with 250 km/h (155 m/h) winds that whipped up a five meter tidal surge and swept about 20 km inland, a grade 5 hurricanes, the highest level possible, devastated 23 districts in the south western part of Bangladesh. Gigantic walls of water smashed into the coastline, washing away everything in their path. The backwash dragged hundreds of people into the sea, bodies were towards the

Fig.2. Physical facts and path of two severe tropical cyclones in Bangladesh

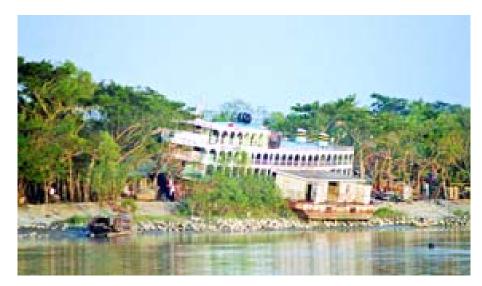
from Fig.3 showing a three storied ferry comes on the ground due to storm surge of Sidr 2007. The coast in western Bangladesh has the forest (Sundarbans), the world's largest forest of mangrove trees. This region is the least populated coastal area in the country and has been part of a major reforestation effort in recent years. The portion of coast likely to receive the highest storm surge levels of 20-25 feet is virtually unpopulated. However, storm surge levels of 10-20 feet are still likely to affect areas with a population of at least a million, to the east of the Sundarbans forest, and inland from the forest.

Fig.3. Three story ferry comes on the ground due to storm surge of Sidr 2007 (Nayadigonta)

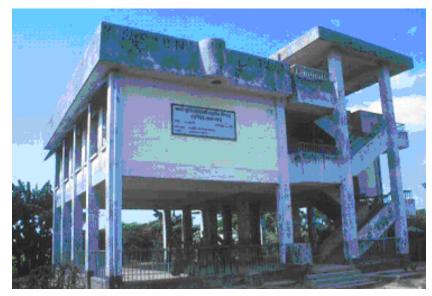
The government has taken a number of countermeasures to prevent the lives of the peoples in the coastal regions especially after the Great Bhola Cyclone of 1970. An example of concrete cyclone shelters that was built in the cyclone prone area is shown in Fig.9. The construction of cyclone shelters was accelerated after the 1991 cyclone. This process is continued till to date and

further reinforced after the recent cyclones. Bangladesh now has over 2500 multi-purpose cyclone shelters some of it is used as primary schools also. The recent warning system in Bangladesh is fairly effective at notifying the population of an approaching cyclone. Earlier many residents were chosen not to evacuate to the shelters, since most of them are in poor condition with minimum or no maintenance at all. But now-a-days, peoples of the country are aware and showing much more response to the weather information than earlier, that saves many lives in 2007.

Fig.9. Cyclone shelter in coastal area of Bangladesh to save peoples from cyclones
