# Severity of Flood Embankments in Bangladesh and Its Remedial Approach

Hossain, M.Z. and Sakai, T.

M. Z. Hossain and T. Sakai. "Severity of Flood Embankments in Bangladesh and Its Remedial Approach". *Agricultural Engineering International: the CIGR Ejournal*. Manuscript LW 08 004. Vol. X. May, 2008.

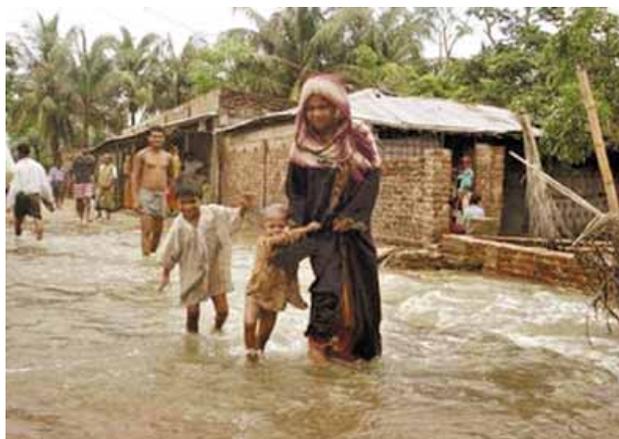
The breaches at cross dams and inundation of low-lying areas are shown in Fig.1. Many villages were inundated as tidal surge lashes many areas of coastline from Cox's Bazar to Khulna via Bhola. Fifty fishermen were dead including 40 fishermen were missing and scores of thatched houses were damaged in islands of St Martin and Maheshkhali as a cyclonic storm crossed Chittagong-Cox's Bazar coast. Besides, about 150 houses were damaged by the storm accompanied by tidal surge of about 3 feet and also damaged a dozen of schools and madrashas. About 50 kutcha houses were damaged. As the storm crossed the Coax's Bazar coast, the tidal surge flooded low areas of Maheshkhali, Kutubdia and Chokoria.

Figure 1. Breached at cross dams and low-lying areas inundated (The New Nation, 2007/06/02)

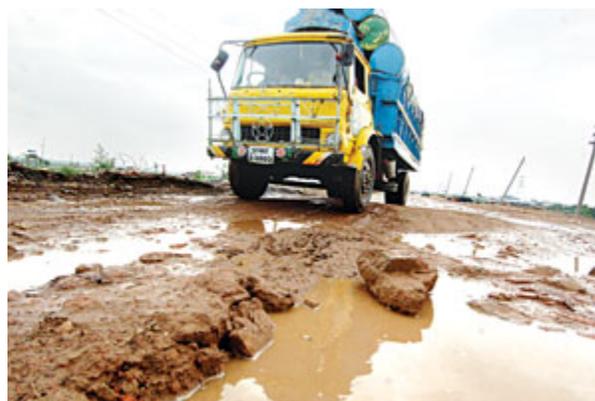
Figure 2 shows the damage of Gabtoli- Mitford connecting embankment that occurred due to heavy rain, transportation and movement of vehicles without paying any attention of the continuous erosion of the embankment. There are much other such type of embankments which are just breaches due to improper management and leaving it without taking care timely.

Figure 2. Damaged Gabtoli- Mitford Connecting Embankment (Zazadi 2007/05/11)

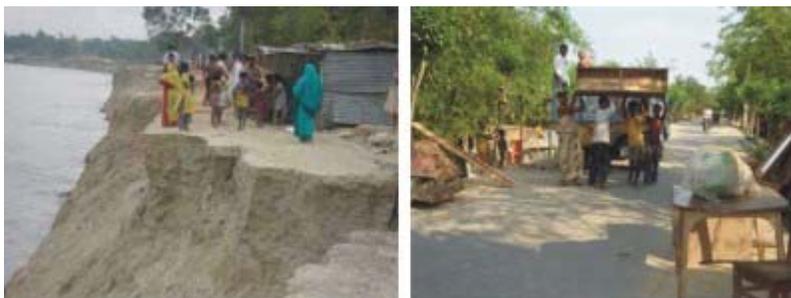
The collapse of Jamuna embankment is depicted in Fig.3. Five Sirajganj Upazilla bear the brunt, embankment collapse threatens town. Sudden swelling of the mighty Jamuna has triggered massive erosion along its western bank in five Upazilla of Sirajganj district. At least seven kilometers of the flood control embankment from Khokshabari to Bhatpiary has collapsed into the river in just two weeks. About 1200 meters of the embankment at Ranigram point collapsed and the rest 4000 meters in the same area are vulnerable. The embankment at Ranigram point is vital among five other points of the 52km Brammha-putra flood control embankment between Sirajganj and Kazipur. Sirajganj town is threatened with erosion as the embankment collapses in more areas. Water Development Board (WDB) could not take any step to repair the embankment

due to fund shortage. Erosion is a regular phenomenon but it has taken a serious turn ahead of the season in 2007.

Figure 3. A family watches with great worries as the Jamuna erosion approaches their homestead (Left) while another homeless family in Khokshabari in Sirajganj Sadar shifting their house to a safer place (Daily Star 2007/06/02)

The WDB invited tender to build an embankment on the western bank of Jamuna covering the five vulnerable points, involving Tk 1.5 crore. Government assured of funds for reconstruction of the embankment but it is yet to be mobilized. At least 3500 homesteads and about 1500 acres of croplands in 35 villages in the five Upazilla have already been devoured by the Jamuna in two weeks. The five affected Upazilla Kazipur, Sirajganj Sadar, Belkuchi, Shahzadpur and Chowhali. Kazipur, Sirajganj Sadar and Chowhali Upazilla are worst affected. People close to the river areas were dismantling their houses and shifting to safer places. Thirty-five more villages in the five Upazilla were under threat. Water level of Jamuna near Sirajganj town was also rising by two to three feet everyday. About 12000 people who lost their homesteads have taken shelter on highlands and on both sides of roads. Banis Ali, 36, of Charpara village said he lost his homestead three times in last several years. He has taken shelter on a road at Khokshabari Natunpara village. The erosion-affected villages are Ranigram, Gunergati, Khokshabari, Panchil, Dwiarpanchil, Shimla, Bhatpiari, Simantobazar, Shuvogachha, Meghai, Natun Meghai, Natuarpara, Shoydabad, Randhunibari, Gachhabari, Shahpur, Rajapur, Shohagpur, Chala, Kaijuri, Gudhibari, Beltoil, Potazia, Sonatuni, Enayetpur, Betil, Jalalpur, Gala, Khaskawlia, Ghorjan, Chowhali, Umorpur and Sowdiachandpur. More areas went into the river every year due to bank erosion. A large number of families have become homeless and over 300 hectares of cropland washed away due to erosion by Jamuna on its right bank of Takukderpara in Shariakandi upazila of Bogra district. Structures constructed at a cost Tk 175 crore have been threatened at Maghai and Shimla areas in Sirajgonj. In Chandanbaisa Union Parisad, about 50,000 people in three unions in Shariakandi affected due to the collapse of the main embankment at Talukderpara.

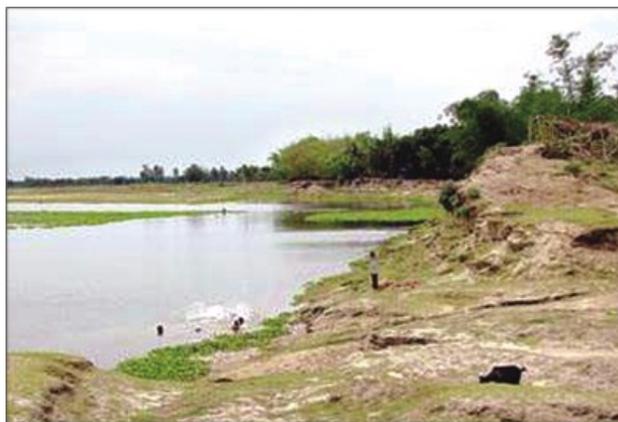
Earlier breach of Karatoa river embankment at Kishamat Cherenga village in Polashbari in Gaibandha is shown in Fig.4. Several thousands people from different villages in Polashbari upazila at a rally at Kishamat Cherenga village have appealed to the local administration and the Water Development Board (WDB) to renovate the breached portions of Karatoa river

Figure 4. Breach of Karatoa River Embankment at Kishamat Cherenga Village in Polashbari in Gaibandha (Daily Star 2007/05/14)

The embankment breached at four points in Kishamat Cherenga, Nayapur, Bishawnath and Bogulagari and is vulnerable at more 24 points. Several lakhs people feared to be affected in the coming monsoon if these are not repaired. The embankment was constructed by WDB in 1991 to save the people of Hossainpur, Kishoregari and Darbastha unions from flood and erosion. The villagers alleged that the embankment breached as it was not constructed as per specification, causing recurring floods in three unions. It is known that the allocation of funds was made but the work could not be started due to complexity in land requisition. The flood in 2005 caused a loss of at least Tk 10 crore in damage to crops, cattleheads, and roads. In last three years, Karatoa changed its course in Kishmat Cherenga and took a U shape touching the embankment. Local people earlier demanded re-excavation of one kilometre area of the river to straighten it to reduce water pressure on the embankment. But no step was taken in this regard.

embankment before the upcoming monsoon to save the area from flood. But the breaches are not renovated despite allocation of Tk 84 lakh for it. The villagers offered all possible help by supplying bamboo, wood and labor and said the breaches can be renovated in only two weeks if 500 laborers are engaged.

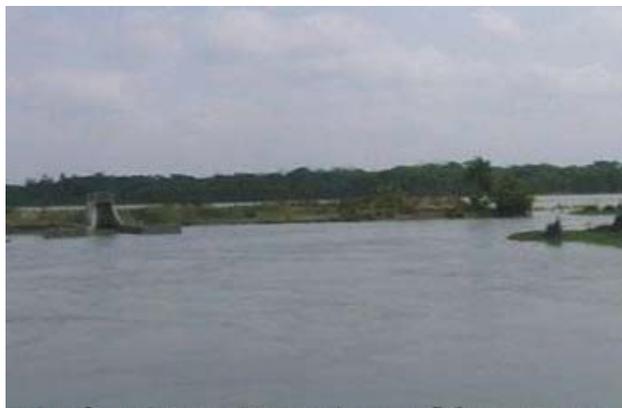
Inundated croplands in Patuakhali Sadar upazila following breach of Lohalia river embankment at Shoula village is shown in Fig.5. The tidal surge that swept the coast washed away shrimps from at least 50 farms and damaged crops on about 2,000 acres in 12 villages in Patuakhali Sadar and Baufal Upazilla. The tidal surge entered the villages as the Lohalia river dam constructed by Water Development Board collapsed at Shoula village in Sadar upazila during the tidal surge. The affected villages are Shoula, Kakrabunia, Idrakpur, Pajakhali, Palerdanga, Nazirpur, Kuripaika, Pratappur and Vaila in Sadar upazila and Bamnikathi and Adabaria in Baufal upazila. Crops like maize, grand nut, sweet potato on about 2,000 acres were totally damaged. The WDB constructed the sluice on Shoula canal at a cost of Tk 25 lakh in 2000. The sluice gate has become more vulnerable as it was not carefully planned after survey. At least three sluice gates should be constructed to control the pressure of water and protect the dam.

Figure 5. Inundated croplands in Patuakhali Sadar upazila following breach of Lohalia river embankment at Shoula village (Daily Star 2007/05/14)

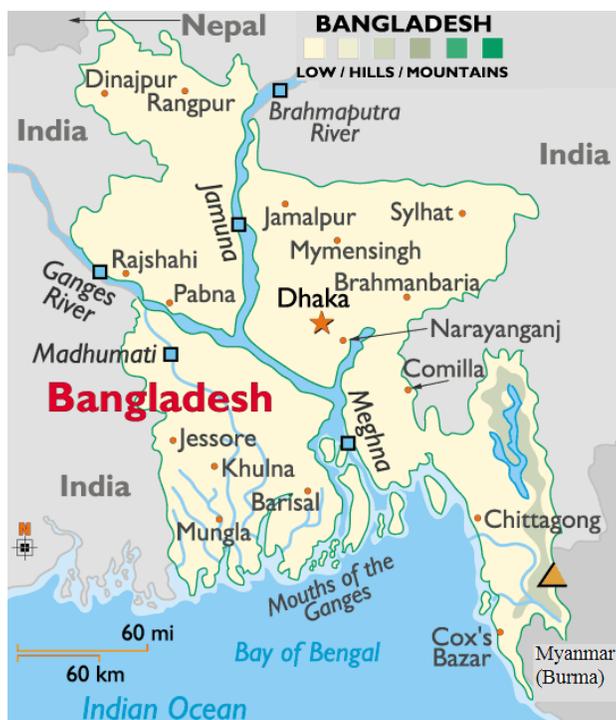
In order to understand the flaws of the current embankments to flood control in Bangladesh, we need to be familiar with certain basic facts regarding the land and rivers of Bangladesh as given below. The fundamental physical fact regarding Bangladesh is that, together with West Bengal, it constitutes a delta. While most other deltas are creation of single rivers, the Bengal delta is the creation of three mighty rivers, namely the Ganges, the Brahmaputra, and Meghna (Fig.6).

Figure 6. River Systems of Bangladesh

The combined catchments basin of the Ganges, the Brahmaputra, and Meghna measures to 1758000 square kilometers, which is more than 12 times the size of Bangladesh. The amount of sediment carried annually by the rivers of the Bengal delta is about two billion tons. This is far more than any other river system anywhere in the world. Under average conditions, from June to September, 775 billion cubic meter of water flow into Bangladesh through the main rivers and an additional 184 billion cubic meter of stream flow is generated by rainfall in Bangladesh (Islam, 1994). The amount of water flow and silt will be increased more in the future due to global warming, deforestation and top soil exposure. The construction of embankments to control flood has to be thought in the context of the above facts and trends.

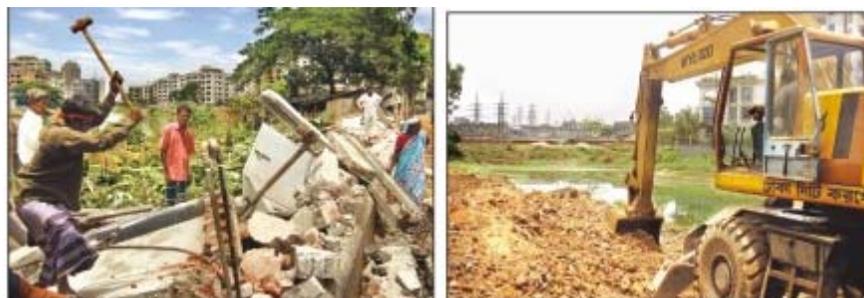
Figure 7. Recycled produced due to demolishment of buildings (Daily Star 2007/05/13)

In order to fulfill the suggested aim, first, we can proceed by using the locally available material for construction of embankments. This will not only facilitate to reuse the material of surface water bodies such as re-excavating the rivers, ponds, khals, dighis and bils but also make riverbeds wide. Now-a-days, it is well known that Bangladesh is headed toward a situation of extremes, whereby very low lean season flow will be accompanied by very high peak season flow. Only a massive excavation program can enable Bangladesh to cope with this twin problem of extremes simultaneously. It will not only enhance surface water storage capacity, which will thereby lower the flood height but also facilitates to store water which will counteract the shortage of water during the lean season. Second, it is important fact that there is a lot of recycled materials produced in Bangladesh every year which creates environmental problems (Fig.7). These materials can be easily obtained with lower cost. This is a big advantage to repair and reinforce the earthen embankments. When necessary, new embankments can be constructed

by the re-excavated and recycled materials. However, to save money, it is always a good idea to repair the existing ones than to construct entirely new ones.
